OHIO RIVER BASIN
GREENLICK RUN, FAYETTE COUNTY
PENNSYLVANIA

NDI No. Pa.-355
GREENLICK RUN DAM

PHASE I INSPECTION REPORT
NATIONAL DAM INSPECTION PROGRAM

PREPARED BY
GAI CONSULTANTS, INC.
570 BEATTY ROAD
MONROEVILLE, PENNSYLVANIA 15146
OCTOBER 1978

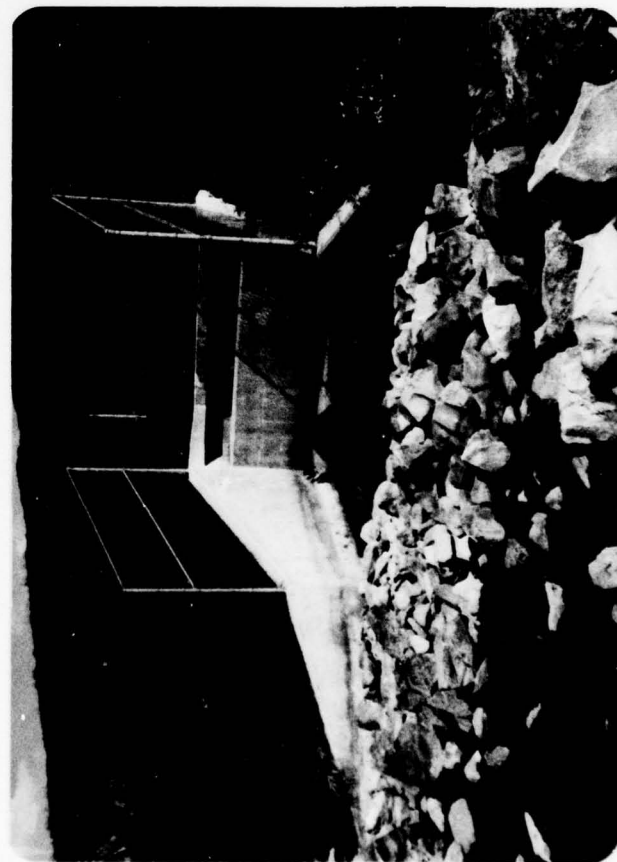
3. Outlet Conduit. The only portion of the low level outlet conduit which could be visually inspected was the discharge end (see Figure 7 and Photograph 7). The concrete portion of the discharge basin is in good condition with only slight evidence of any deterioration. Immediately beyond the basin is a riprap-lined channel approximately 20 feet in length and 20 feet in width. The channel appears to contain an excess of riprap that may obstruct discharge through the outlet channel during high discharges (see Photograph 7).

VISUAL EXAMINATION OF	OBSERVATIONS	REMARKS OR RECOMMENDATIONS
CRACKING AND SPALLING OF CONCRETE SURFACES IN OUTLET CONDUIT	Very minor spalling observed in the concrete portion of the outlet basin. No concrete deterioration was noted at the vertical riser intake.	
INTAKE STRUCTURE	Low level intake was submerged during the visual inspection and was not observed. The vertical riser crest was visible due to the low pool level and appeared to be in excellent condition.	
OUTLET STRUCTURE	Good condition. No discharge was observed through the outlet conduit or the toe drains projecting through the outlet basin wingwalls on either side of the outlet conduit during the inspection.	
OUTLET CHANNEL	Trapezoidal or near rectangular channel with a riprap channel floor extending approximately 20 feet from the outlet basin. An apparent excess of riprap was observed at the discharge end of the outlet basin which could create tailwater effects.

PHOTOGRAPH 7 Detail view of the outlet structure. Note the embankment toe drain outlet in the right wingwall (left in photo). Note also the excessive riprap at the outlet apron.

c. Remove the excess riprap observed in the outlet channel to eliminate undesirable tailwater conditions.
